Safety Audit Report

Stage 1 – Preliminary Design

Proposed School Access, Junction Modifications and Pedestrian and Bus Improvements, Aim High School, Safechester

Spoonford District Council

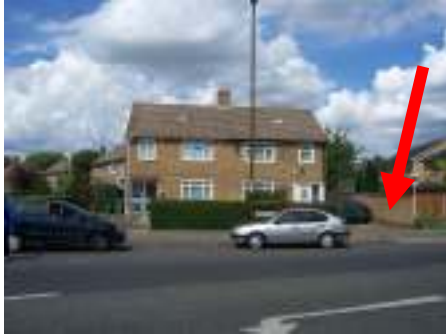
Audit Item No.	Audit Team Observation and Recommendation	Site photograph
A2.1	GENERAL	
A2.1.1	<p>Problem <i>Vehicle crossover may be lost as a result of proposals</i></p> <p>Location <i>Noway Road to the east of the proposed priority junction at Someways Road</i></p> <p>The Audit Team noted the proposed kerb realignment along the north side of Noway Road to accommodate the new priority junction layout at Someways Road, and noted that this buildout is adjacent to two houses in this location, one of which has a dropped kerb/ vehicle crossover.</p> <p>The Audit Team were concerned that the residents may be unable to enter and exit their driveway safely without crossing the footway, which could increase the potential for conflict, and reduce accessibility.</p> <p>Recommendation:</p> <p>That the retention of the vehicle crossover be shown on plans at the Detailed Design stage.</p>

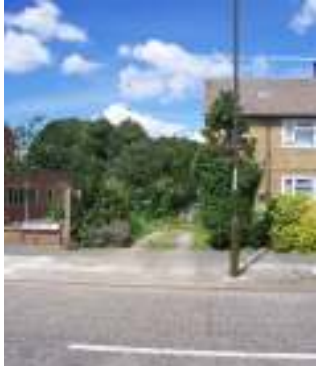
Audit Item No.	Audit Team Observation and Recommendation	Site photograph
A2.1.2	<p>Problem <i>Stopping up of Someways Road could prevent vehicles from accessing the westernmost property</i></p> <p>Location <i>Western end of Someways Road to the east of the church on Allways Road, in the vicinity of the proposed stopping up</i></p> <p>The Audit Team noted that the stopping up of Someways Road involves the provision of a 9m kerbed area to the east of the access to the church on Allways Road, and noted on site that a private drive exited onto Someways Road in this location.</p> <p>The Audit Team were concerned that this area of footway could prevent vehicles from accessing the driveway at the far western end of Someways Road, which may encourage the undertaking of unexpected or illegal manoeuvres which could compromise safety.</p> <p>Recommendation:</p> <p>That the boundaries of the stopping up be carefully located so as to preserve access to private drives in the vicinity, at the Detailed Design stage.</p>

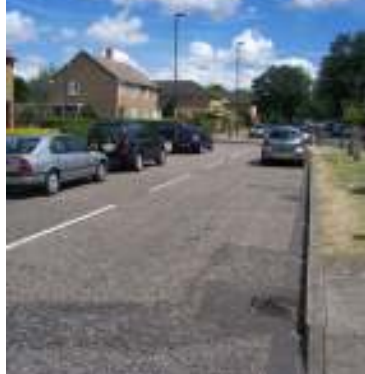
A2.1.5	<p>Comment <i>Additional drainage provision may be required</i></p> <p>Location <i>Allways Road and Someways Road</i></p> <p>The Audit Team noted that gullies are located along Allways Road in the vicinity of the kerb realignment and along Someways Road in the vicinity of the stopped up area and would expect to see proposals to ensure that adequate drainage is provided here, at the Detailed Design stage.</p>

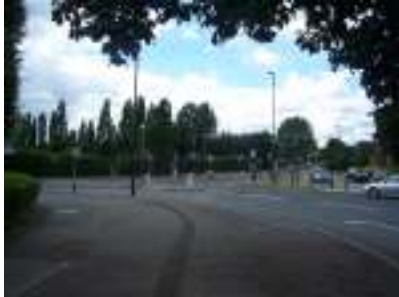
Audit Item No.	Audit Team Observation and Recommendation	Site photograph
A2.1.6	<p>Comment <i>Statutory Undertaker’s Plant, signs and lamp columns located within extents of kerb realignment</i></p> <p>Location <i>Eastern side of the junction of Noway Road at its junction with Allways Road</i></p> <p>The Audit Team noted the presence of Statutory Undertaker’s Plant within the vicinity of the footway realignment in this location and would expect to see proposals for the relocation or adjustment of these to be shown on plans at the Detailed Design stage.</p>
